Manhole Inspection Summary

Manhole # S69W__009MH

Location Address: **6601 Chandlery St.**

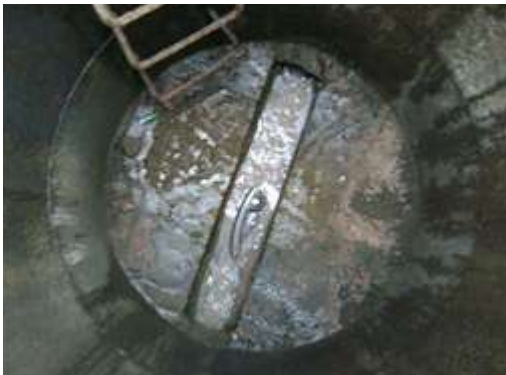
Defect 2

Comments **MANHOLE COVER BROKEN AND THE MISSING PIECE IS IN THE CHANNEL.**

Broken piece of manhole cover in channel.

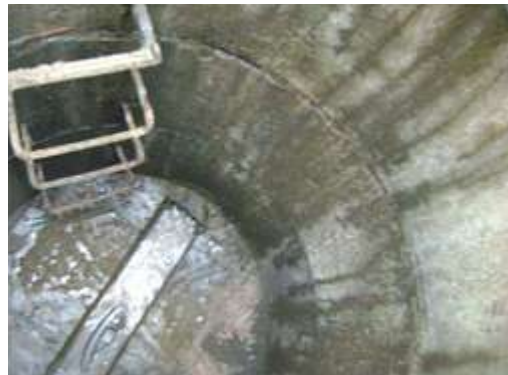
Defect 4

Infiltration: ☐ None ☐ Joint ☒ **Cracks** ☒ **Mortar** ☐ Roots ☐ Wall

Infiltration

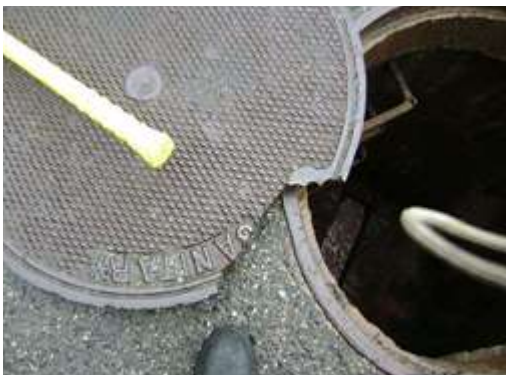
Defect 1

Type: **Sanitary** Condition: **Broken** Cover Material: **Cast Iron**

chunk missing from MH cover

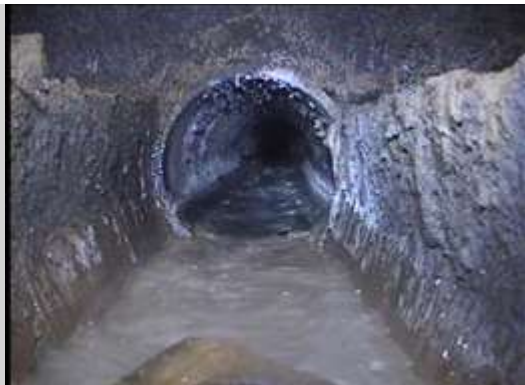
6 O'Clock Inflow

Pipe Height: **8.4** (in.) Rod and Bar (Angled)
Pipe Material: **Clay** ☐ Pipe Lined
Invert Depth: **7.63** (ft.) Flow Characteristics: **Fast**
Deposits: ☐ None ☐ Mud ☐ Sludge ☐ Debris ☒ Grease
Silt Depth: **0.25** (in.) Deposits Extent: **Light**
Infiltration: **None** Pipe Seal Cond: **Sound**
